WAYNE STATE UNIVERSITY

MAIN CAMPUS  
**COMPREHENSIVE  
DEVELOPMENT PLAN**

PHASE I: INVENTORY & ANALYSIS

JULY 1981

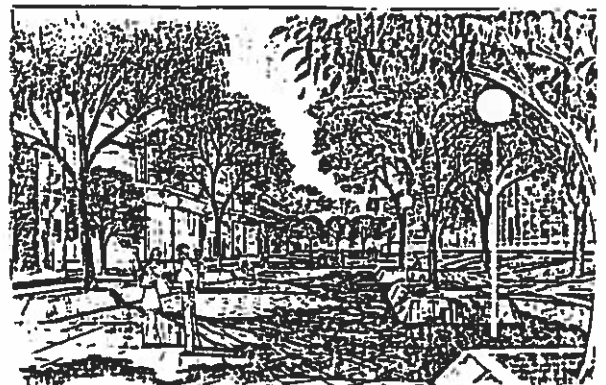
FIGURE 9  
FERRY MALL, 1969

The plan divided the Main Campus into three basic functional zones: academic, student housing, and physical education and recreation. The earlier Pilafian design principles on the use of academic superblocks, contemporary design, planning and structural methods for all University buildings were continued. Parking was located at certain key anchor locations on the periphery of the Campus. Particular attention was paid to the design of open spaces between University buildings (Figure 9).

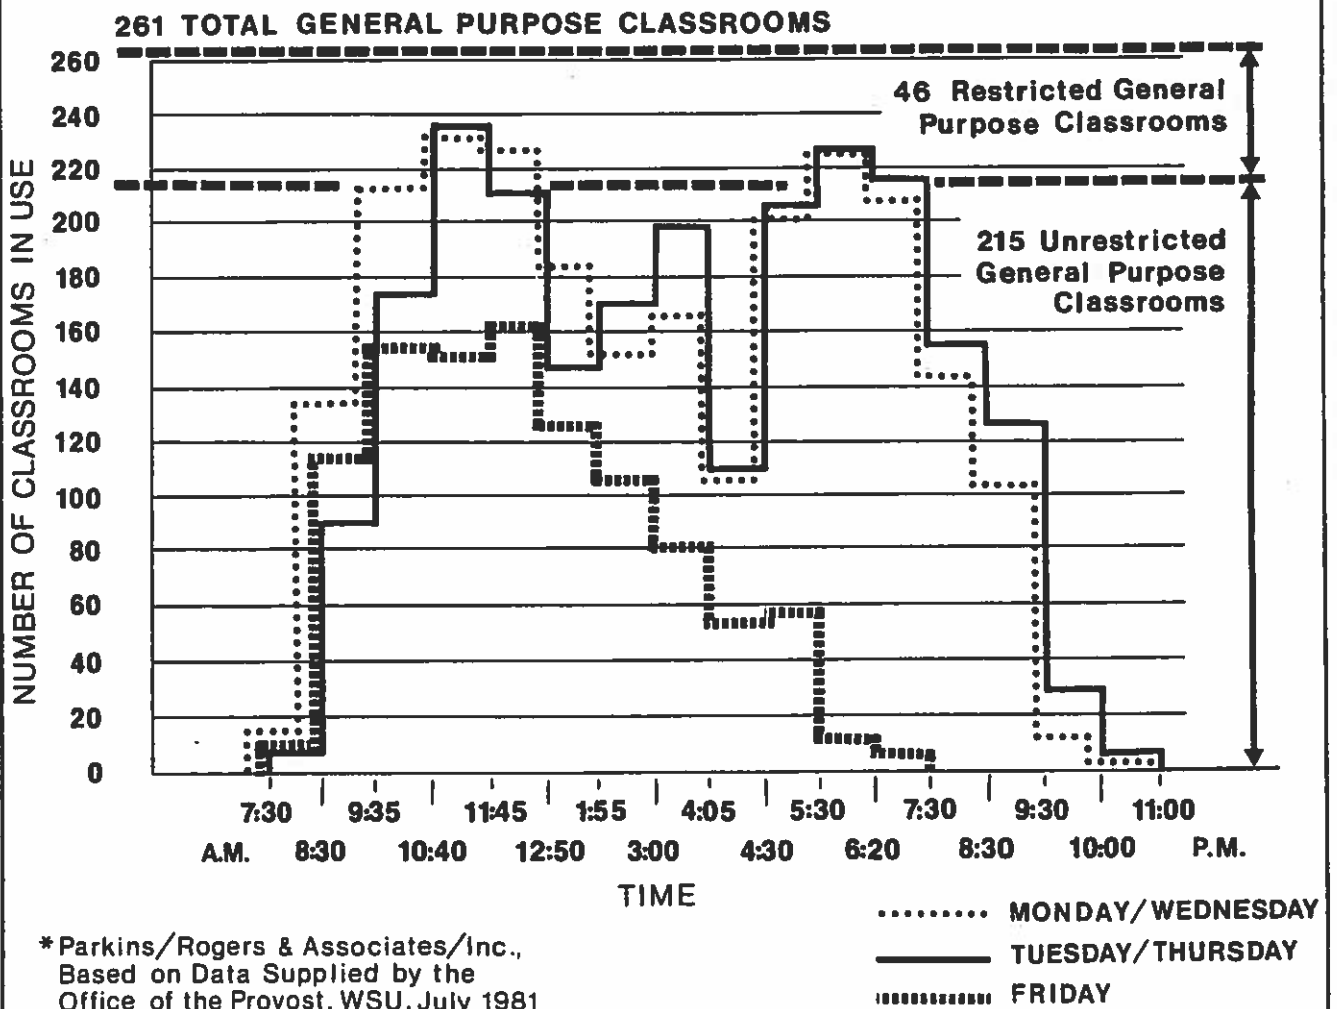
Figure 12

**HOURLY CLASSROOM USE FOR ALL COLLEGES**  
**Monday through Friday, Winter 1980-1981**  
**WAYNE STATE UNIVERSITY/MAIN CAMPUS \***

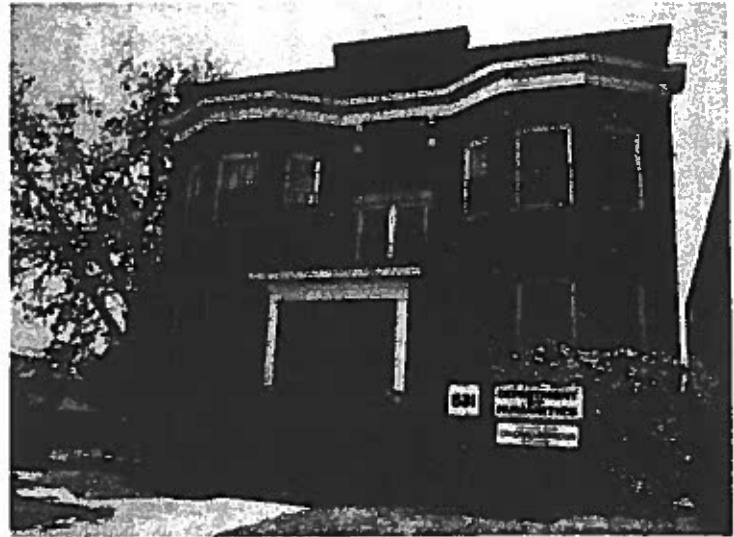
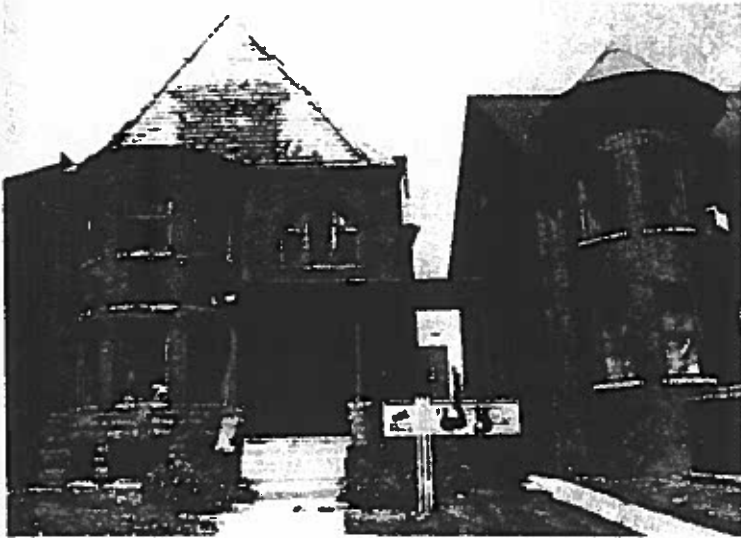
FIGURE 13 - EXAMPLES OF STRUCTURAL QUALITY

STANDARD CONDITION

DEFICIENT CONDITION

SUBSTANDARD CONDITION

Each marginal structure was inspected and categorized according to the number of major and/or minor defects observed. A major defect was one that indicated major deterioration or weakening in the primary structural elements of the building. A minor defect was one that indicated major deterioration or weakening in the minor structural elements, or minor deterioration or weakening in the primary structural elements of the building.

A standard survey form was used which included a checklist of structural elements (roof, walls, foundation), non-structural elements (windows, roofing), building systems (heating, electrical), maintenance features (painting) and building codes (including barrier-free regulations). The structural inspection form was used as the basis for preliminary cost estimates of work necessary to bring the properties into compliance with local and state codes and regulations and making it usable for a 20 year life span. In addition, each building was evaluated from the standpoint of its architectural and/or historical significance.

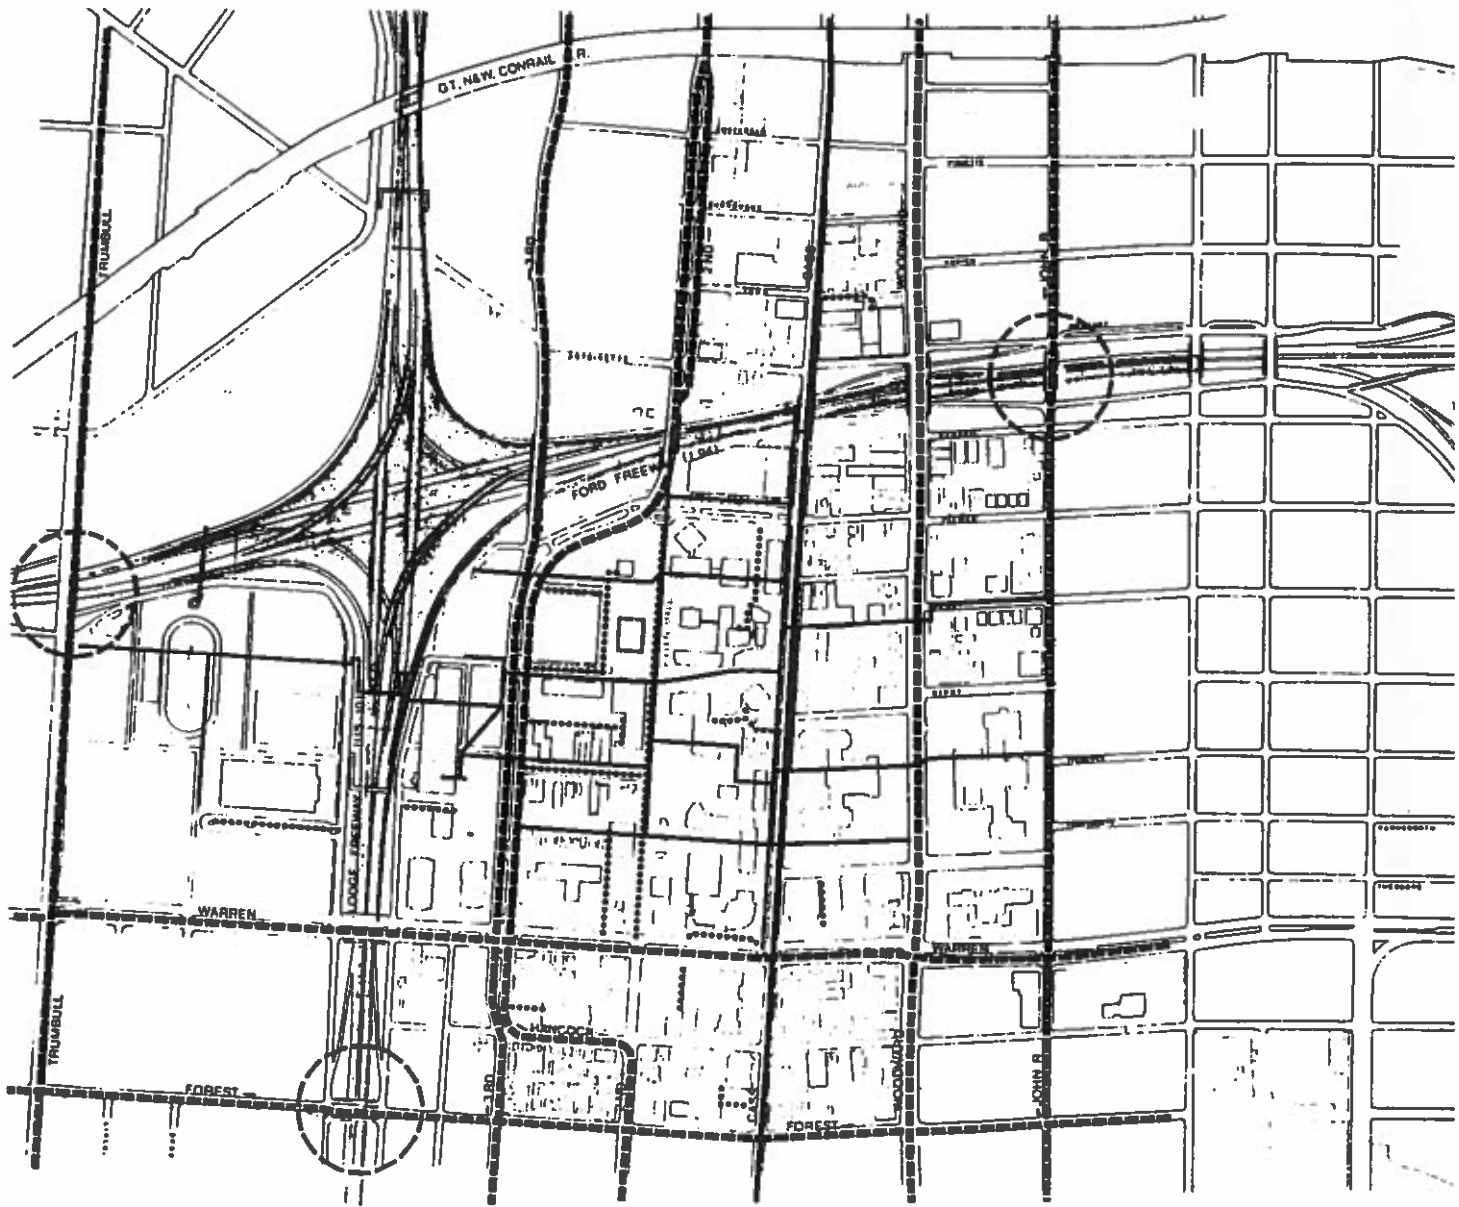
Map 6  
PUBLIC  
TRANSPORTATION

- 
- ..... Bus Route
  - Bus Stop
  -
